Rebuilding the title and restoring a derelict, hurricane-damaged Chris-Craft Commander 27 are worth the grime and the grunt work.

Text and photographs by Reuel B. Parker

Above—The rebuilt 1965-vintage 27' (8.2m) Chris-Craft Commander JB had been abandoned at the Riverside Marina in Fort Pierce, Florida, following the devastating hurricane seasons of 2004 and 2005. The boat and her title were completely rebuilt by the author for a client, who will keep her at a slip in City Island, New York.

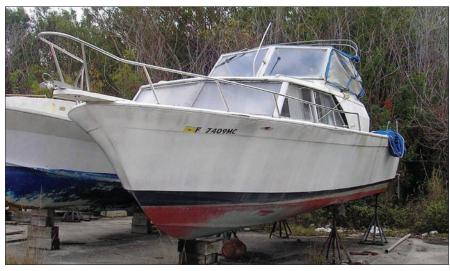
Above—The Commander as found in Florida. The boat was in sound structural condition, had the advantage of a simple single-engine configuration, and a relatively efficient, dry-running hullform. Below-Much of the wood interior had been ruined by rodents and water intrusion.

The engine was obviously hopeless. Someone had removed its cover and left it exposed to the elements for years. The interior had been infested by rats and palmetto bugs. The acrylic front cabin windows were cracked, fogged, and leaking badly. The bimini top was ruined, as were the side curtains and cockpit cover. All plumbing and electric components were ruined. Nearly all original deck hardware was severely corroded. The marine toilet was beyond rebuild, as were all appliances. The mattresses for the V-berth were horrid, but oddly the settee cushions were serviceable, though filthy. The bulkheads and cabinetry were largely intact but needed extensive renovation. The entire boat was plastered with American flag decals.

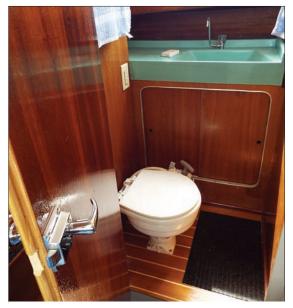
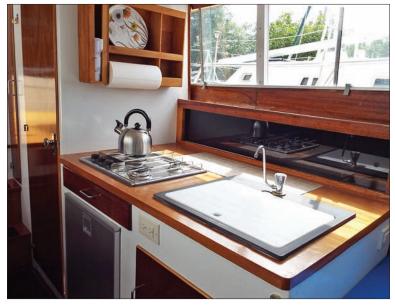
Left—The molded fiberglass lavatory sink in the head compartment was one of the few salvageable elements from the original interior. The mahogany bulkheads were also saved and refinished. Right—The new galley includes new gas cooktop, shelves, racks, lighting, a black composite sink (covered with a cutting board), a new refrigerator, and a veneered counter with inlaid ceramic tiles.
