35 Commander Shower drip solution

By Tim Miller and Bruce Harkness

Photos of the repair by Tim Miller

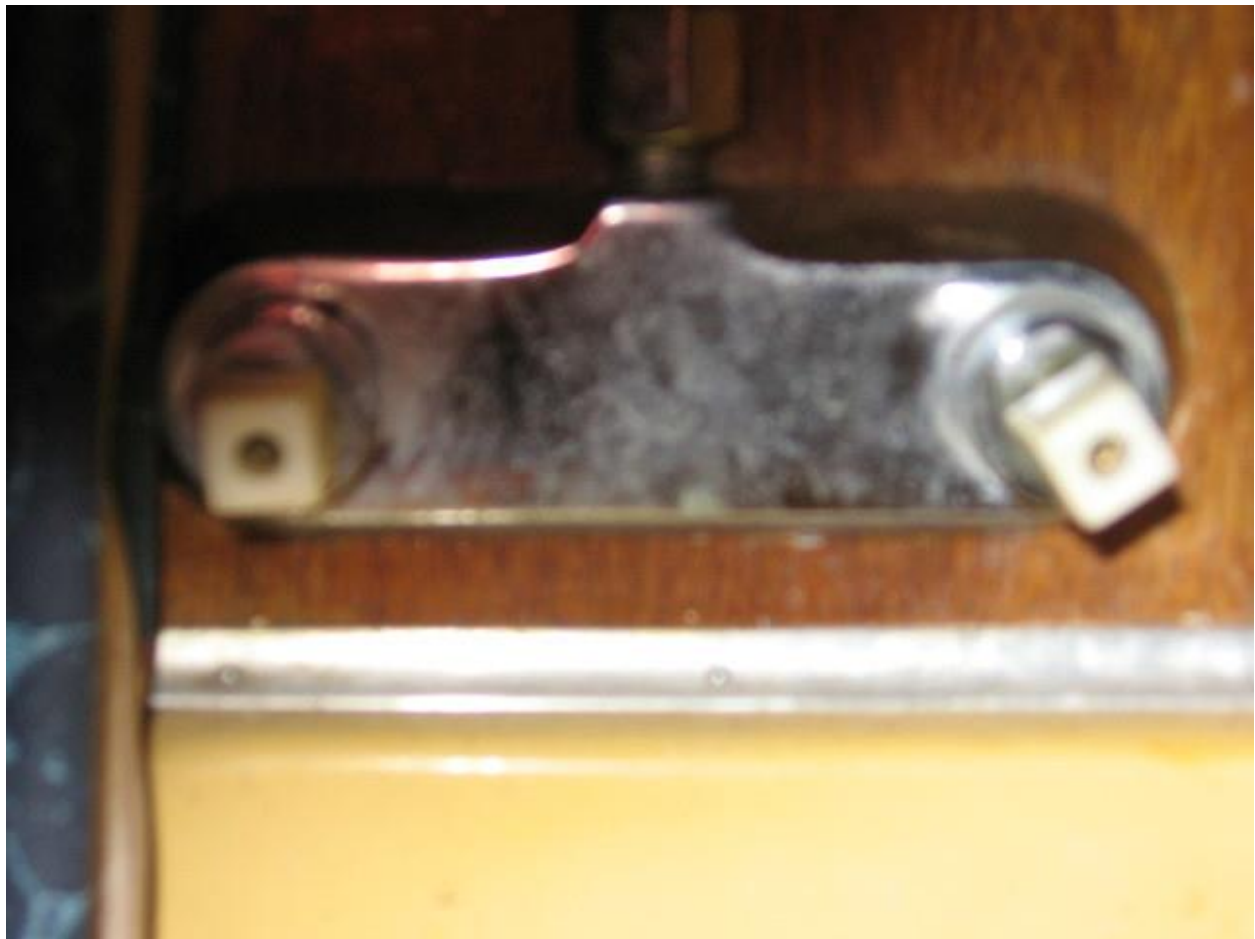
1. Handles off

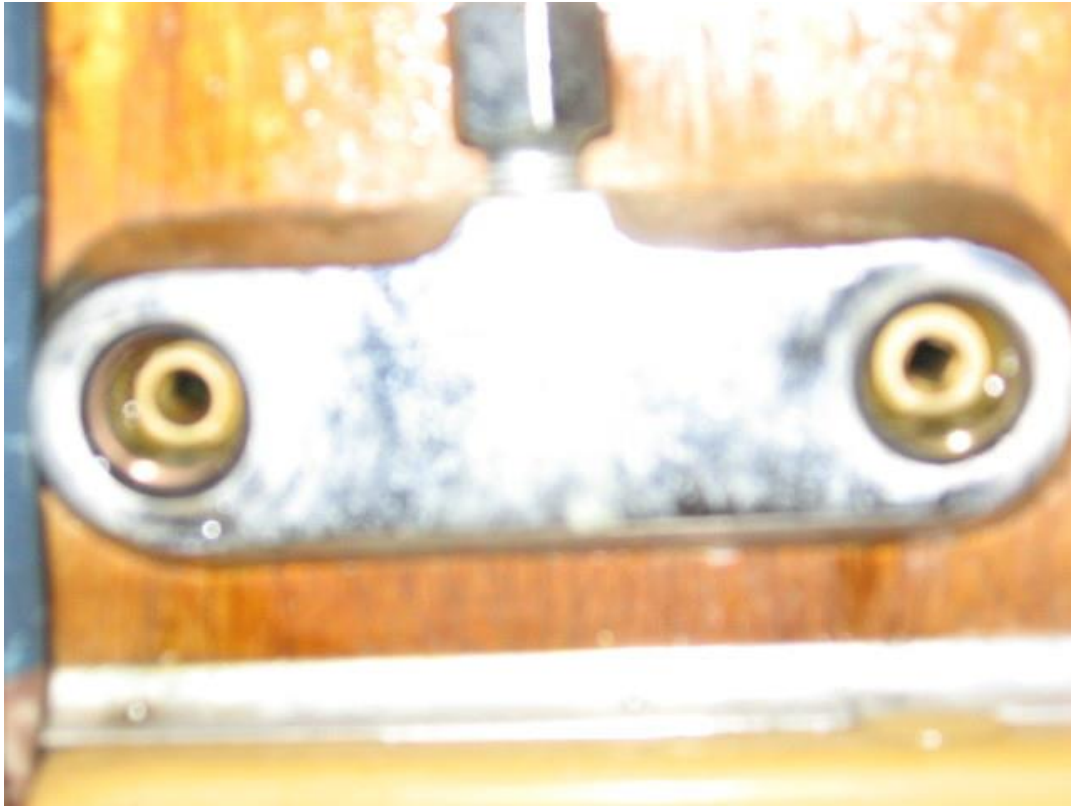
2. Valves out

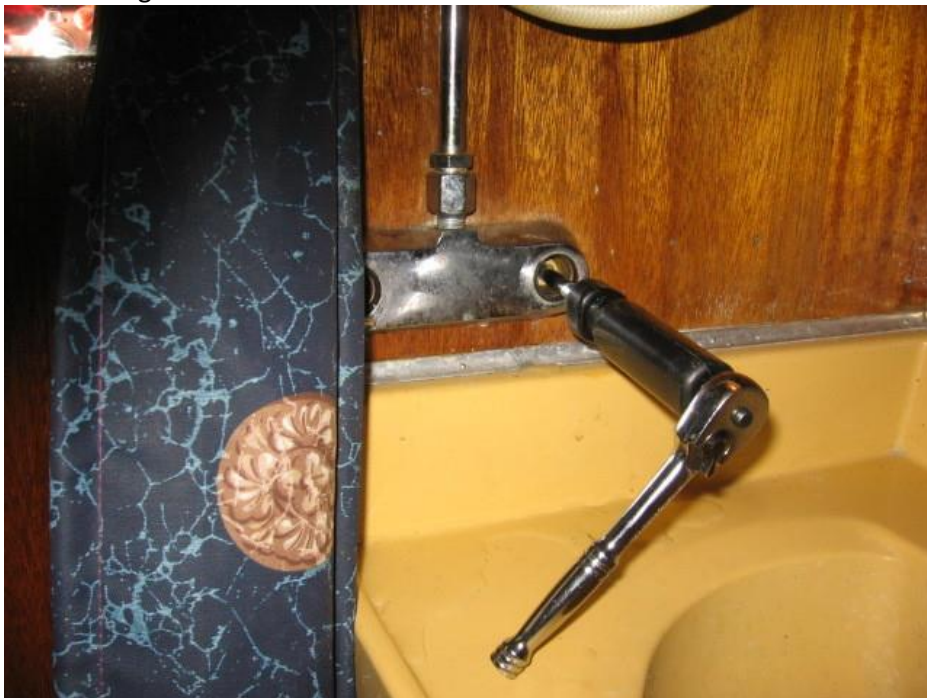
3. Removing seat

I assume a plumbing supply or hardware store would have the proper tool. I used a 1/4 inch square drive extension on one and it worked. Any sort of square bar stock should work also. A screwdriver was also tried on the other, but I ended up chipping away at it carefully and removing the pieces. It would be good to get one out whole so you can match it up. If that fails, I can call the plumbing supply store and get the info on the seats they gave me. I know for sure they were 24 thread/inch. I did not get the part info, in retrospect I should have written in down in the boat logbook.

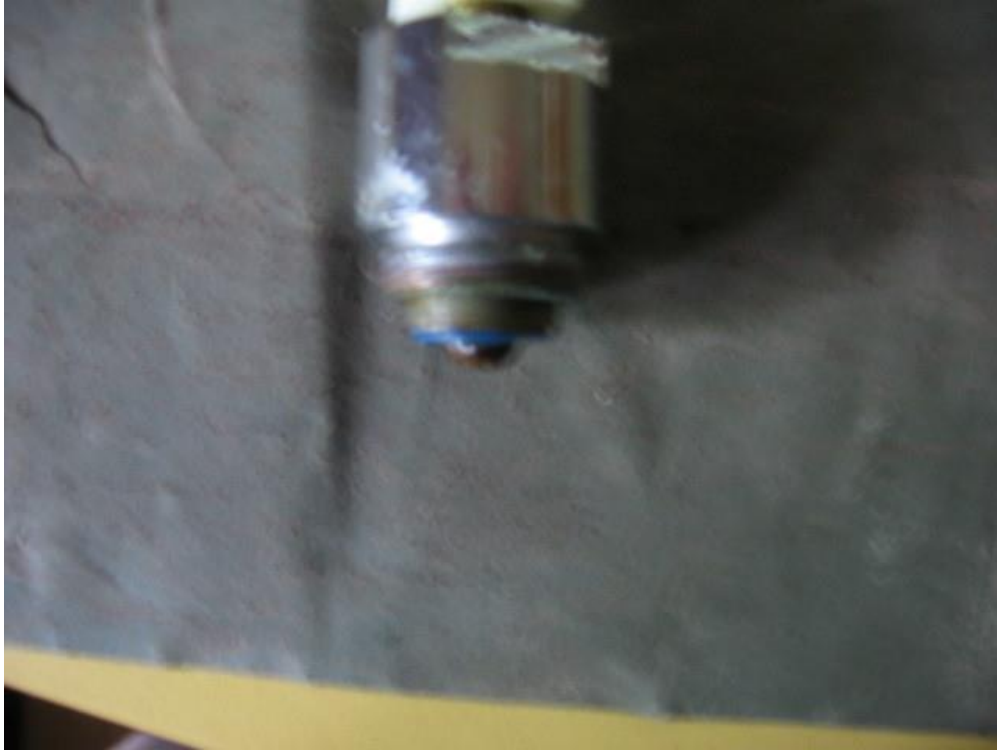
4. Valve with seat and screw

Bruce, is yours the original shepard's crook with the chrome base? Mine seems different internally. It has the seat in the base and the faucets when removed have a stem with a flat neoprene washer held in place with a brass screw. Thanks

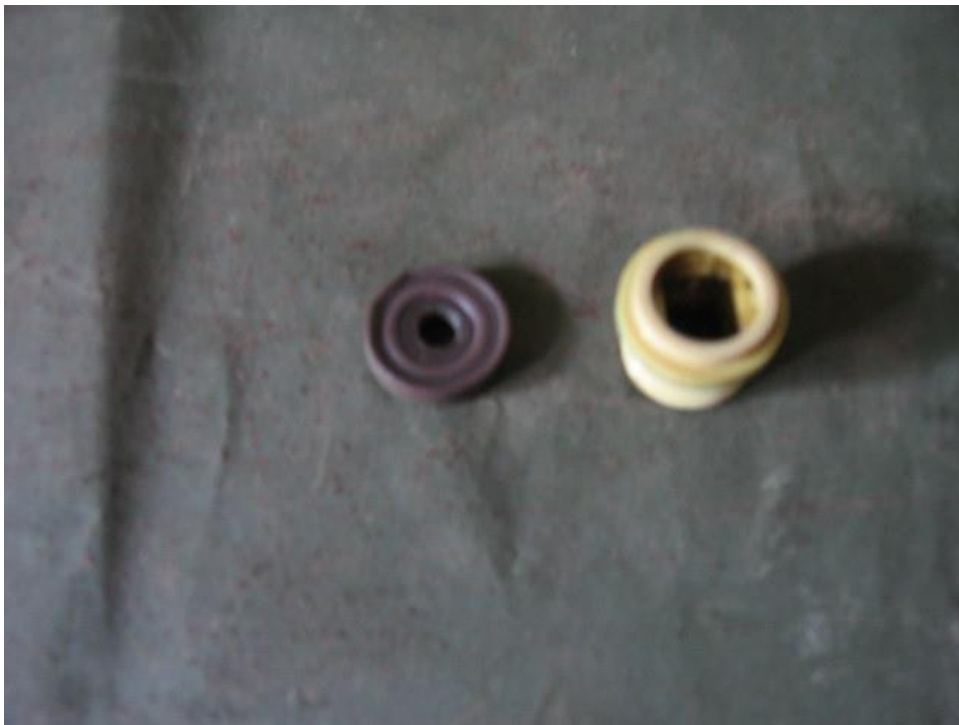
5. Plastic seat and washer

Bruce, how did you get the square seat out. I'm figuring to use the right size screwdriver blade or a pair of square nuts jammed together. It is a plastic seat but a ridge so it works with a new washer but soon imprints a groove from the ridge and successive tightening works until the washer screw bottoms out.

You can see why the old seat is such a poor seal, the new seats have a much broader sealing surface. The sealing surface also protrudes further out towards the cartridge, so you have to back the faucet cartridge out in order to screw it back into the fixture.

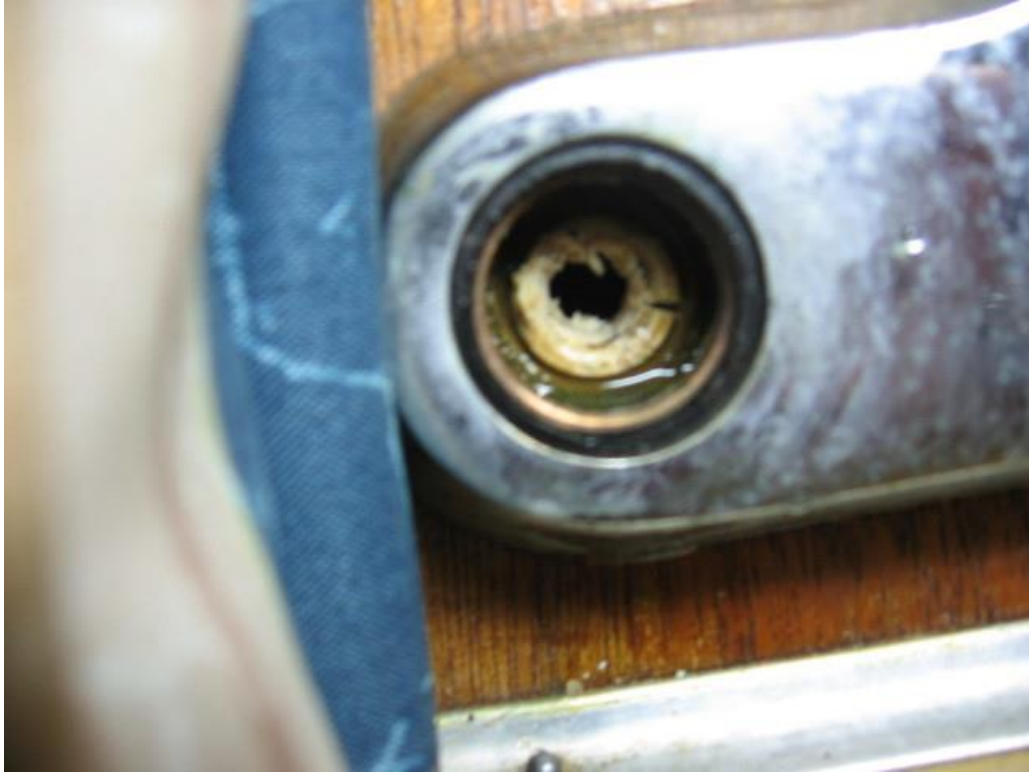
6. Hot water side frozen in place

It worked! The seats have 2-3 times the sealing area of the old plastic seats. They feel much more positive sealing in the hand. The other seat was more difficult to remove. I ended up splitting and peeling it out. They had 1/4 inch drive center holes, but that one was stuck. Your biggest challenge may be removing the old seats.

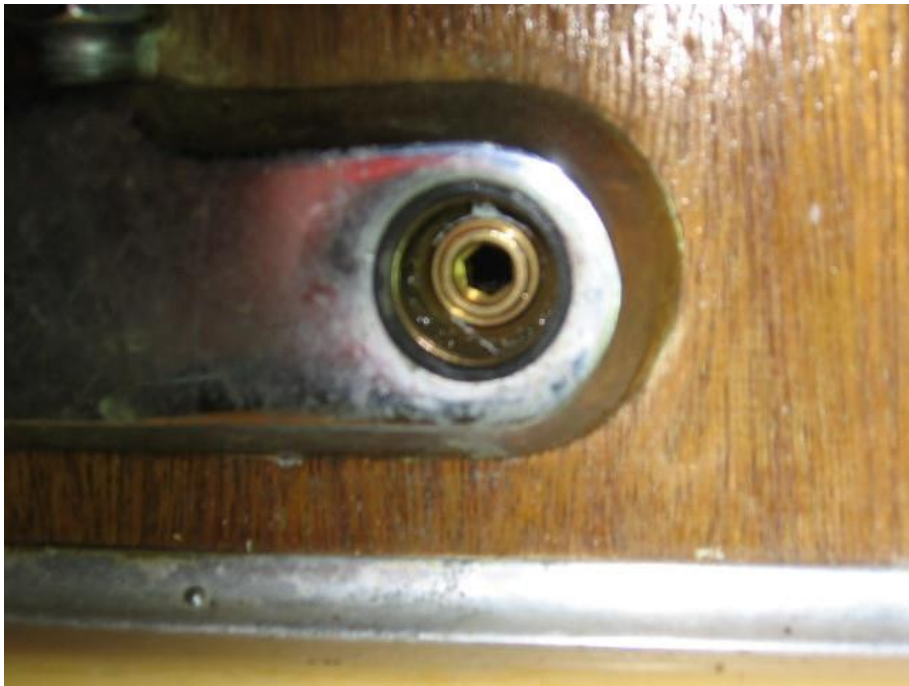
7. Cold water seat in place

Went to a large plumbing supply store in Knoxville. The new brass seats were 7/16 24 thread fine pitch. The counter guys said the cartridges were Illinois Bronze units. They had some new metal knobs that fit. Fitting it tomorrow if the day goes as planned. They said it was critical to teflon or pipe dope the threads on the new seats. At least I won't crack the plastic parts trying to stop the drip.

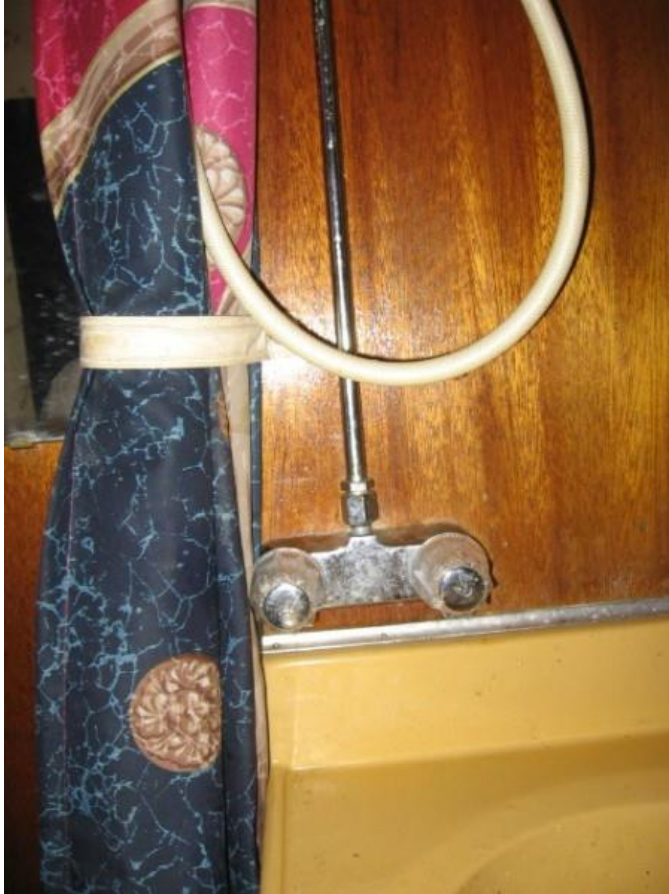
8. Back together
